# River degradation problems along the Bishnumati River corridor in the Kathmandu Basin

N. K. Tamrakar  
(Central Department of Geology, Tribhuvan University, Kirtipur, Kathmandu, Nepal)

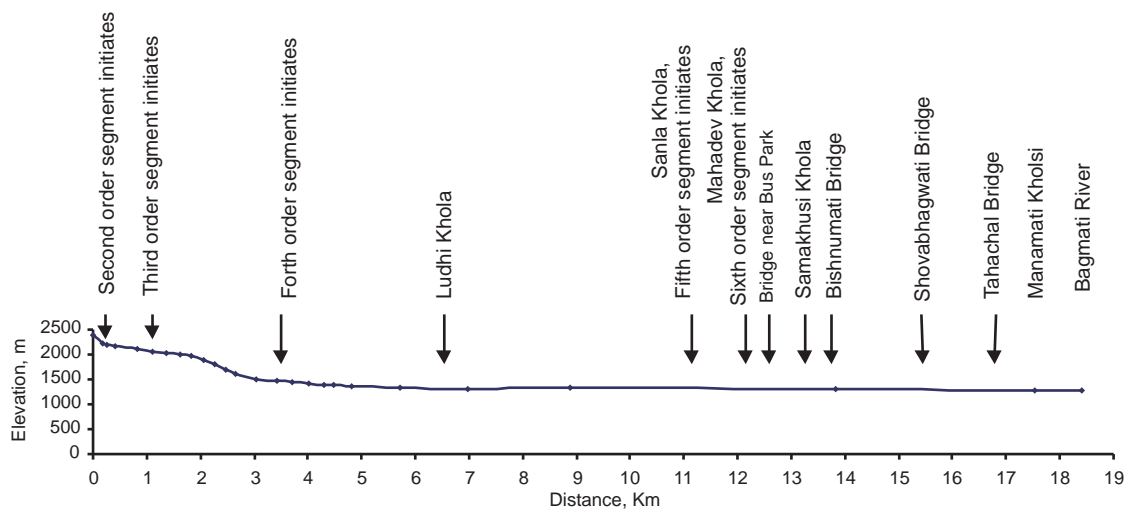
Fig. 6: Profile of the Bishnumati River

The Bishnumati River shows concave up river profile (Fig. 6). Slope of the third order segment is 0.133 and of other segments is below 0.004. The river shows three knick points which exist between third and 4th order segment, 5th and 6th order segments and in Bijeswari area reach. Therefore, head cutting and disequilibrium condition are occurring towards third, 5th and upstream segment of the 6th order stream.

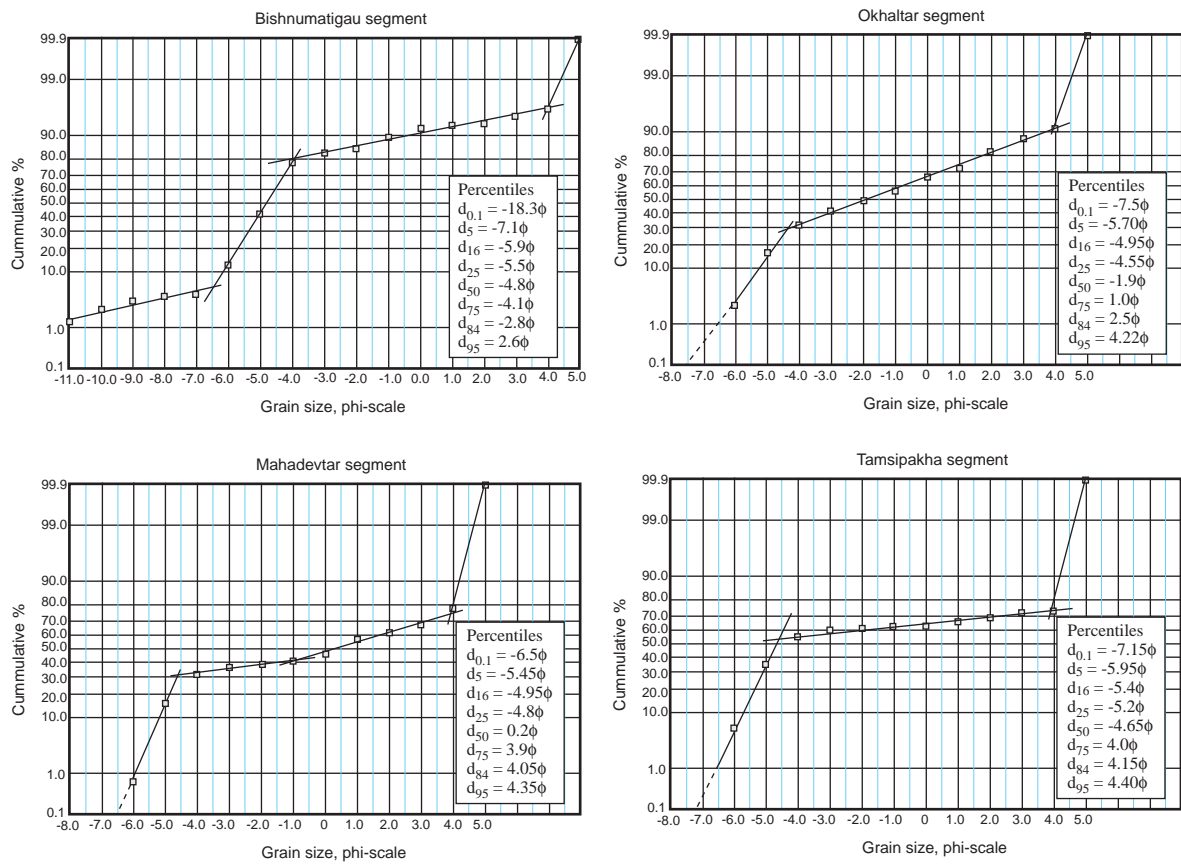
Fig. 7: Probability plots showing nature of curves; each straight line segment represents sub-population travelled in different modes of transport, and estimation of percentiles

Particle size distribution curves of Bishnumatigau segment indicate four distinct sub-populations, which are rolling and creeping, saltation, intermittent suspension, and suspension, respectively from coarse to fine size grades (Fig. 7). Plots of Okhaltar, Mahadevtar and Tamsipakha segments indicate three distinct sub-populations of which coarser and finer sub-populations are more well sorted while intermediate sub-populations are poorly sorted. The coarse sub-population travelled by saltation whereas intermediate sub-population as intermittent suspension (saltation plus suspension) and the fine sub-population

The coarsest particle ( $d_{max}$  values) were obtained by extrapolating the curve representing coarse sub-population. The  $d_{max}$  is two to three times higher in substrate of Bishnumati segment compared to other segments (Table 2). Median particle size ( $d_{50}$ ) is high in Bishnumatigau segment (-4.8 phi) and Tamsipakha segment (-4.65 phi), whereas it is least in Mahadevtar segment (0.2 phi). The high  $d_{50}$  in the former is due to nearness of source rocks and in the latter can be due to contribution by the fifth order Mahadev Khola. All the samples show poor sorting according to the sorting categories of Folk and Ward (1957). Sediments of both Bishnumatigau and Tamsipakha segments are very finely skewed while those of Okhaltar segment is finely skewed, and Mahadevtar segment is coarsely skewed (Table 2). Median size and skewness parameters of Mahadevtar segment are anomalous and are due to excavation of sediments in upstream segment.

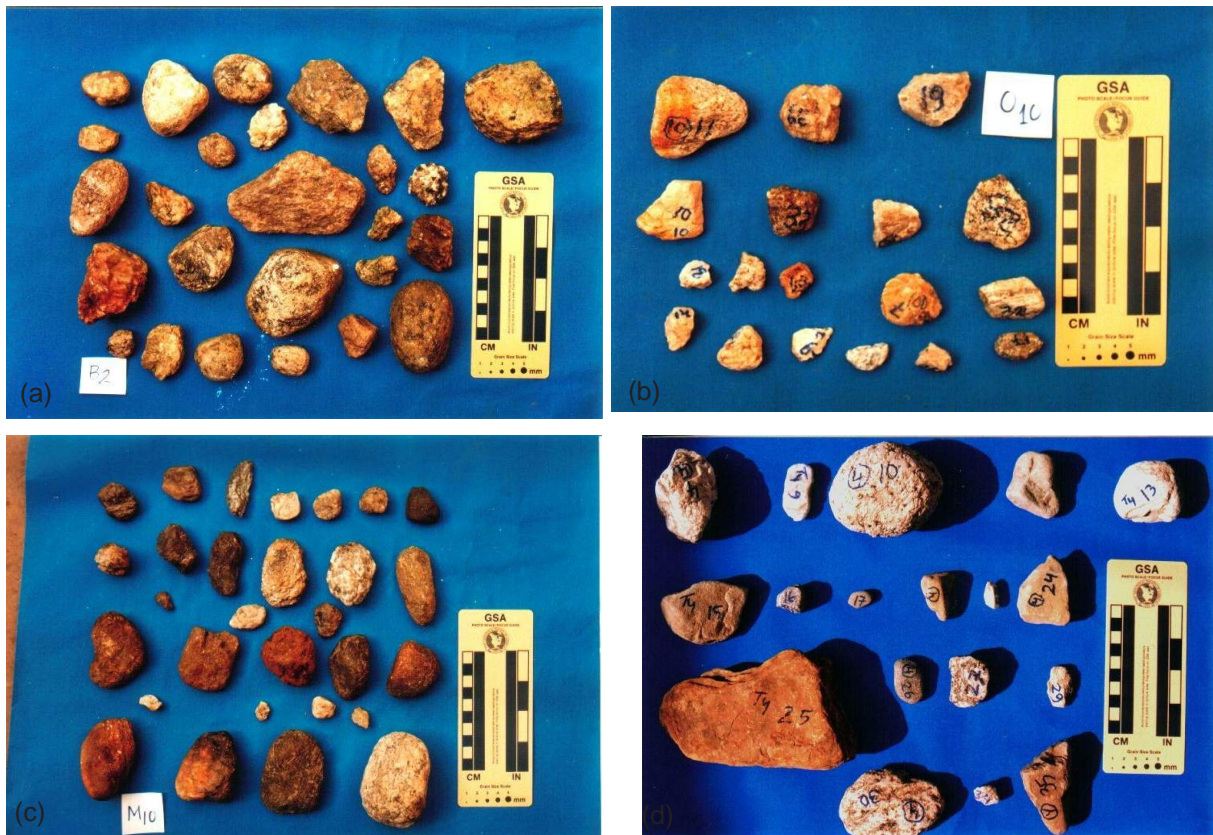
Fig. 8: Gravel sub-samples from (a) Bishnumatigau segment; transect-B2, (b) Okhaltar segment; transect-O10, (c) Mahadevtar segment; transect-M10, and (d) Tamsipakha segment; transect-T4

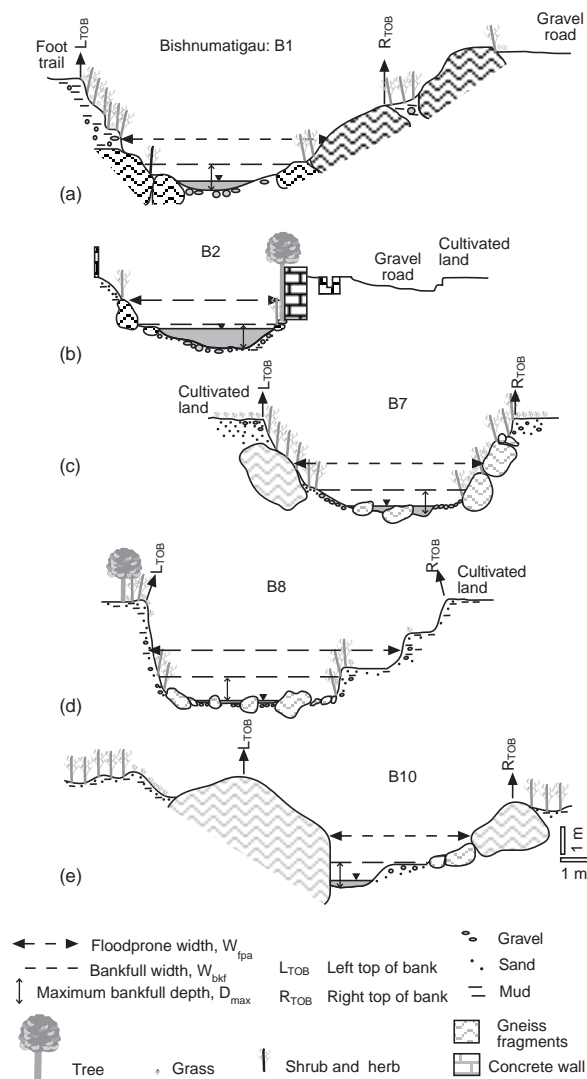
Fig. 10: Cross-sections of transects in Bishnumatigau segment; (a) B1, (b) B5), (c) B7, (d) B8, and (e) B10

characterised by step, riffle and pool. The substrate is composed dominantly of pebble although huge mega boulder and clay also exist in the substrate (Fig. 10). All the above criteria place the Bishnumatigau segment in A4-type stream.

The river banks are lined with mostly shrubs and grass, and few trees. Banks in B1, B7 and B10 transects are mostly covered with megagravel (Fig. 10). Right bank of B2 is confined with a concrete wall. Left bank of B8

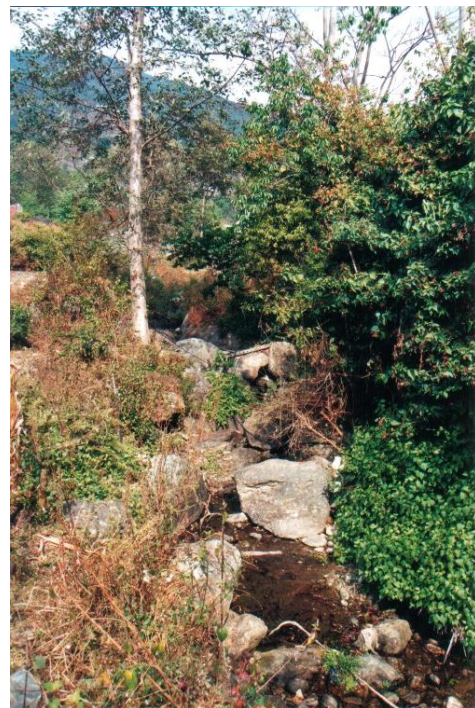
Fig. 11: An upstream view from B5 showing stream bank sediments and vegetation

is steep whereas right bank is stepped for cultivation. The banks in B8 are composed of sandy soil. Distribution of boulder and megagravel in channel and banks can be noticed (Fig. 11). Vegetation in the banks is well distributed.

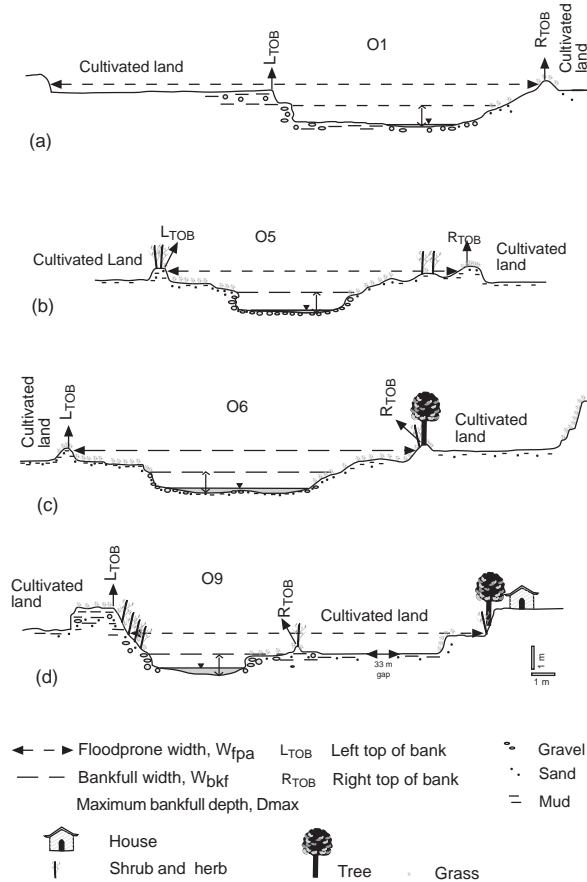
Fig. 12: Cross-sections of transects in Okhaltar segment; (a) O1, (b) O5, (c) O6, and (d) O9

Transects O1, O5, O6 and O9, from downstream to upstream portion have wider floodprone width than the average bankfull depth (Fig. 12). Average depth does not deviate much from  $D_{max}$ . Substrate materials are abundantly gravel and sand (Fig. 13). Bank materials are stratified muddy sand and gravel. Lower banks are mostly eroded. Banks are covered by grass and in some places by shrubs. Few trees are distributed on levees. Riparian vegetation is weak in the downstream segments compared to the upstream one. The banks have been eroded by flows (Fig. 13). In some instances, banks have been protected by bamboo

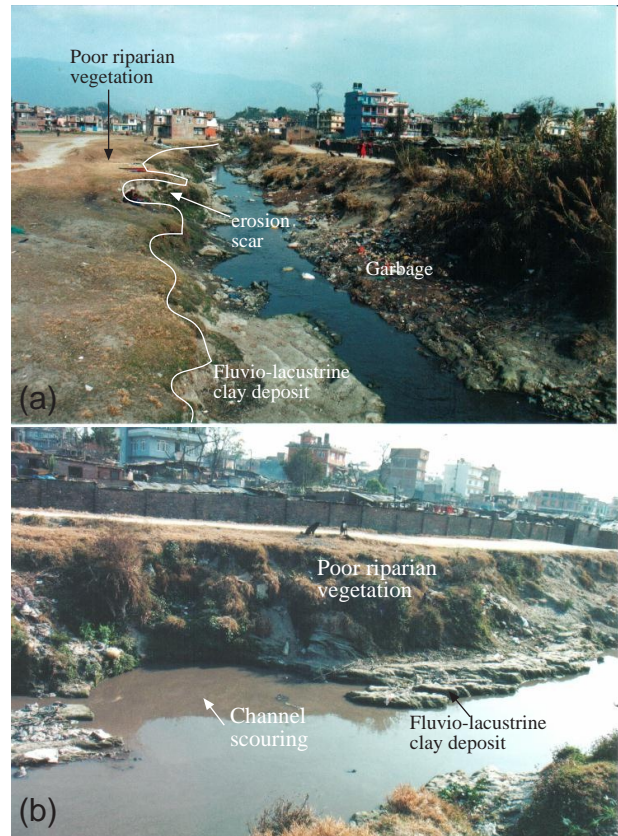
Fig. 15: (a) Upstream view from transect M1, and exposure of clayey bank, erosion scars and poor riparian vegetation, and (b) Downstream view from M3, showing channel scouring, exposure of clayey channel bed, and poor riparian vegetation

Upstream and downstream views from transects M1 and M3 are shown in Fig. 15.

Right and left banks exhibit erosion scars. Riparian vegetation along both banks are poor. The channel width here is not so wide, but the channel is scoured forming deep pools.

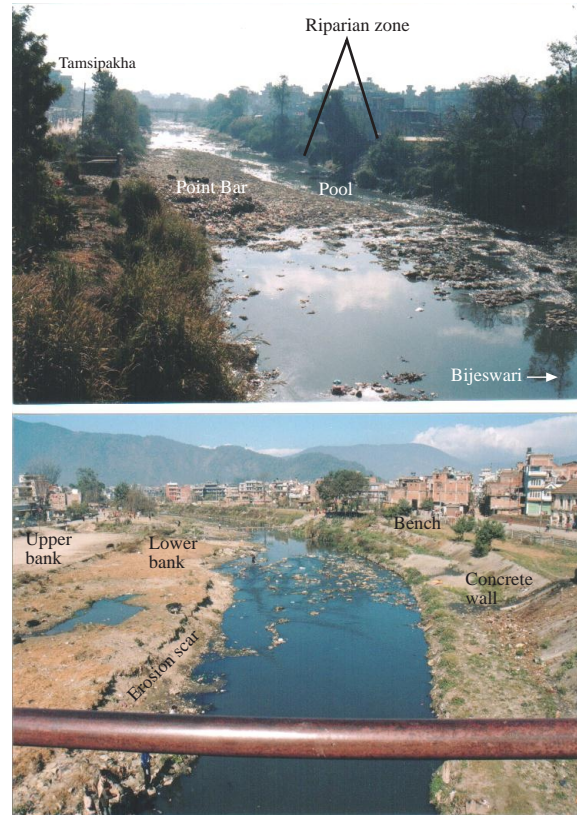
Fig.17: View from the Bijeswari bridge, 50 m upstream of transect T4 in Tamsipakha segment; (a) Downstream view and (b) Upstream view

Height of the top of low bank approaches 3 m in transection T1 (Fig. 16). Increase in height is resulted by incision as well as by infilling of waste materials. Solid waste materials are dumped along the both sides of the river banks and can be observed in T2, T8 and T9 (Fig. 16) as well. On the left bank, a black topped road has been built over the dumped material, whereas on the right bank, a gravel road has been extended. In a reach between Tamsipakha and Bijeswari, the right bank is preserved as a narrow riparian zone (Fig. 17).
